# **COPING STRATEGIES ADOPTED BY INHABITANTS WITH ASBESTOS CEMENT ROOF HOUSES IN SOUTH AFRICAN LEGACY TOWNSHIP**

## ***ABSTRACT***

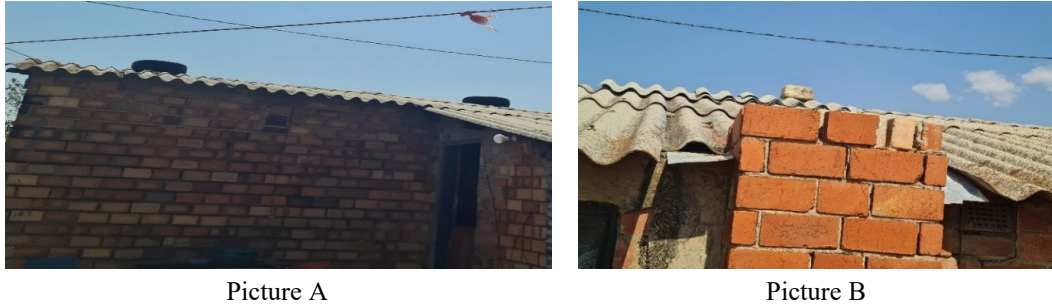
*Figure 1: Pictures of an unsecured asbestos roof support against the wind*

The sheets are replaced or placed on top/below the existing asbestos sheet. In most instances, these were installed near the chimney or where there were big holes in the sheet. For instance, Figure 1, picture B indicate houses where this strategy was used. Noticeably, they additionally place supportive material, in this case, rocks. The first image also illustrates where corrugated iron was added under the asbestos-containing roof, where the redundant chimney is located.

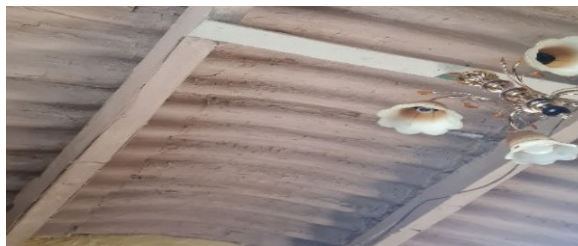
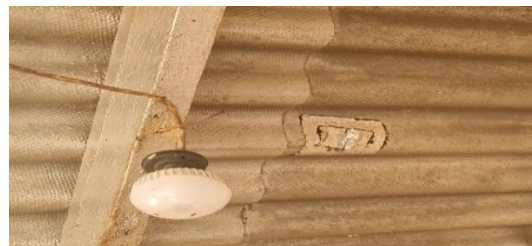
*Figure 2: Pictures of a painted asbestos roof to improve its aesthetics.*

The second strategic theme discussed is sealing holes inside the roof to avoid stepping on the asbestos cement roof, which breaks easily and paints to enhance its appearance, minimise dust and temporarily make sealant stick on the roof. Eight participants stated they tried to seal holes from the inside. While most use this strategy, it is temporary and sometimes used as a minimisation strategy instead of prevention. It is a minimisation strategy because it may not completely prevent water from coming in, as the hole would still be visible from the outside. Still, it would decrease the amount of water drips into the house compared to when it is left unsealed. This strategy was seen in Figure 2, picture D, where the participants used sealants such as silver waterproof tape and multipurpose glue. This indicates its fragility, and the only condition people are willing to seal it. Some participants indicated they painted their roofs inside. They, however, had different reasons for painting them. An example is in Figure 2, picture C, where the participant painted it to make it look better.

Picture C: Dusty roof painted over

Picture D: Dusty roof painted over

For instance, P5 indicated that it is difficult to wash the roof; thus, they painted it to improve the colour, which subsequently peeled off. Additionally, P11 stated that it becomes a bit better when you apply water paint. One participant, P7, said he had painted it a while back and would only be repainting it. His rationale for this is based on the idea that the roofs may be removed any day, and he is worried he would have wasted his money if he painted it today and it gets removed soon after.

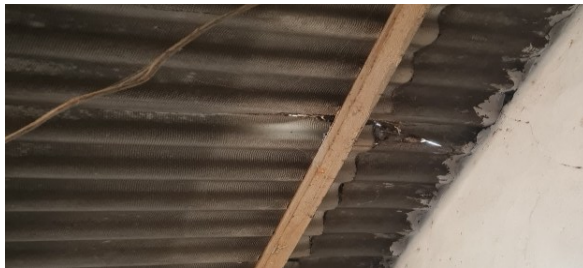
Picture E

Figure 3, picture E, illustrates some of the areas where buckets are used to collect the water from the roof during rain, as pointed out by the participants.

Figure 3: Pictures of a leaking asbestos roof where buckets collect the water during rainfall, and binding wires are installed to the external walls to hold the roof structure.

Participants indicated other strategies they use besides those discussed in the previous sections. These were to place buckets where roofs leak and add binding wires on the walls to support the poles and roof during windy days. Six participants stated they place buckets inside their houses when rainwater drips to prevent their furniture from getting wet and the house from getting messy. While no images were acquired indicating the buckets being used, some participants pointed out places where water drips typically when it rains. For example, P6 pointed out the holes and suggested that they place buckets in those areas during rainfall.

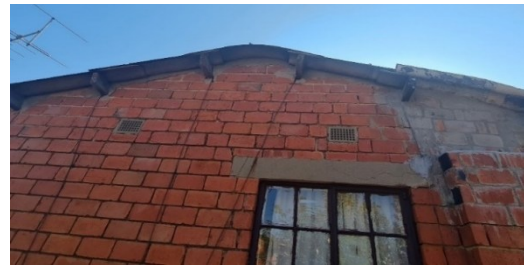
Picture F

The other strategy for the participants' houses was to install binding wires around the external walls attached to the roofing poles. Four participants stated this strategy, and the researcher observed this during the site visits. For instance, P1, in explaining why they had installed these, noted that the father installed the binding wires.

Figure 3, picture F, illustrate different participants' houses where this strategy was observed.
